Manhole Inspection Summary

Manhole # S23QQ1003MH

Insp Date: **12/3/06 2:14 PM**

Location Address: **4700 FALLS RD**

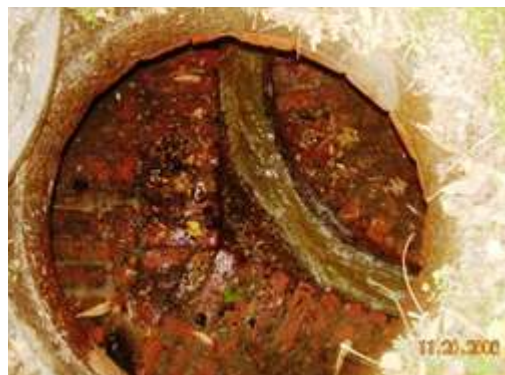
Top View

Frame leaks. Adjustment infiltration.
Bench debris.

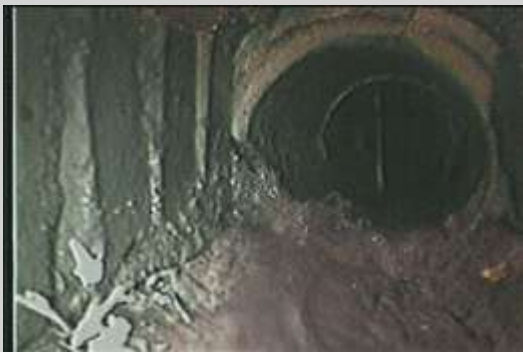
6 in. Circular Gravity Sewer Pipe Out @ 12 O'Clock

Deposits: ☐ None ☒ **Mud** ☐ Sludge ☐ Debris ☐ Grease

Silt Depth: **1** (in.) Deposits Extent: **Light**

Infiltration: **Evidence** Pipe Seal Cond: **Cracked**

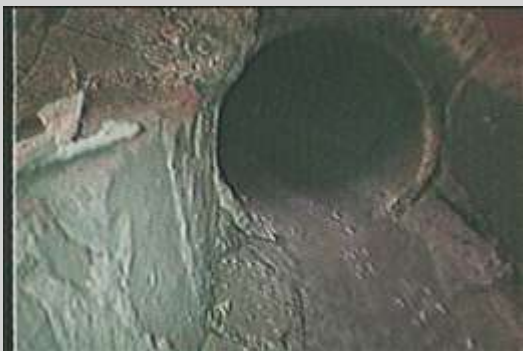
6 in. Circular Gravity Sewer Pipe In @ 3 O'Clock

Channel deterioration.

Infiltration: **Evidence** Pipe Seal Cond: **Cracked**
